BANK DISTRESS OF LOW WATER WEIRS ON BIG CREEK, LA.

S. Paul Miller

February 1978

Final Report

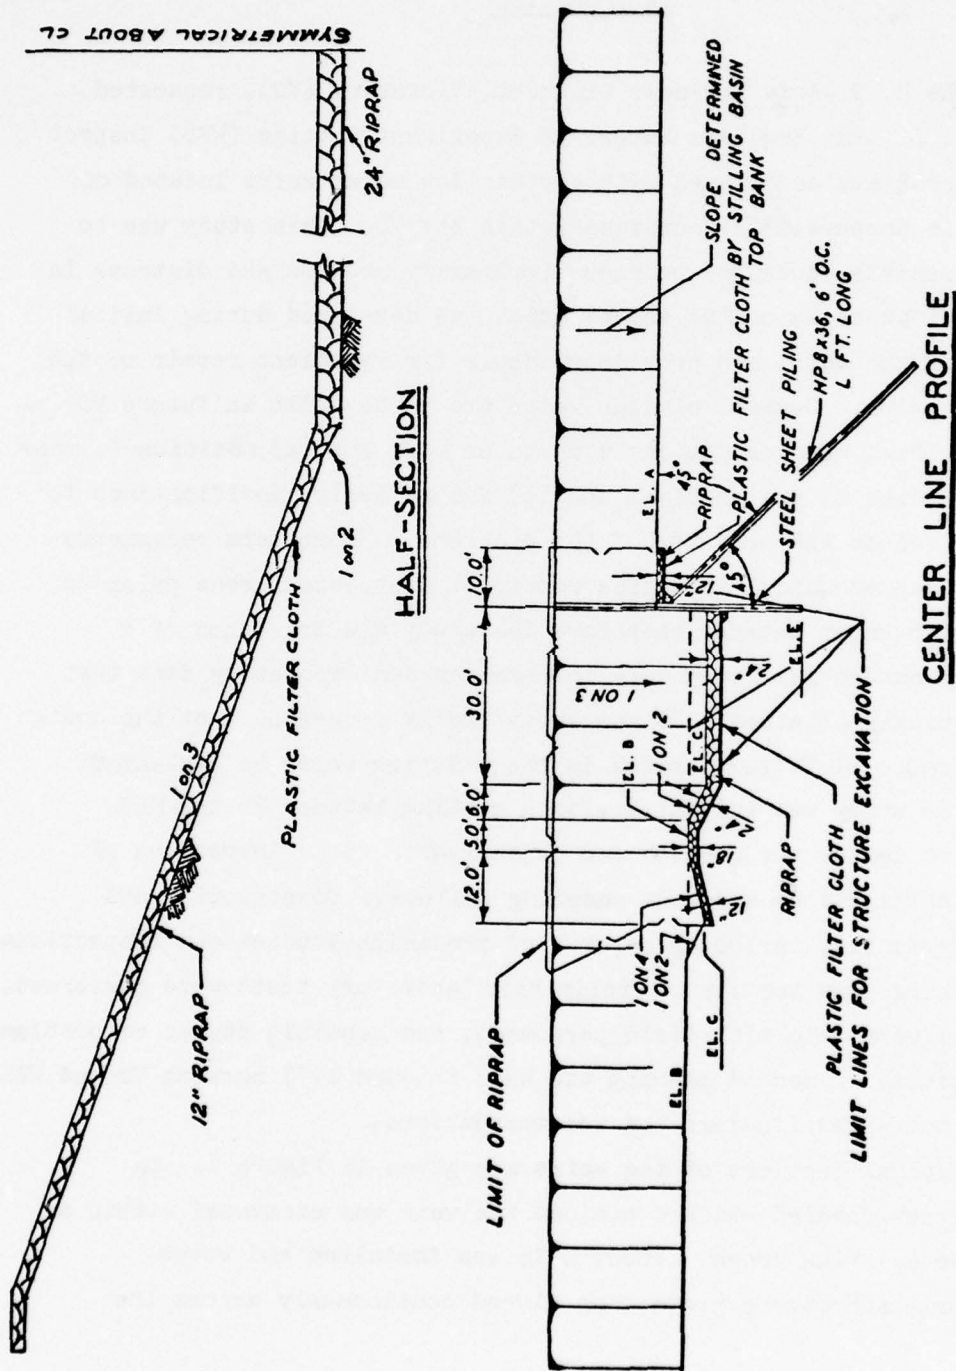
Figure 1. Typical weir cross sections

3. Typical sections of the weirs are given in Figure 1. In general, a new channel which contained the weir was excavated within a bend of the existing creek. Sheet pile was installed and woven filter fabric and riprap protection placed continuously across the

channel both upstream and downstream of the sheet pile. The riprap was placed directly on the fabric. It was evidently placed properly since no damage to the fabric was apparent during field inspection. The slope protection downstream of the sheet piling forms a stilling basin with an end sill. After the sheet pile and slope protection were installed, the excavation was connected with the creek and the old channel blocked to allow flow only through the weir.

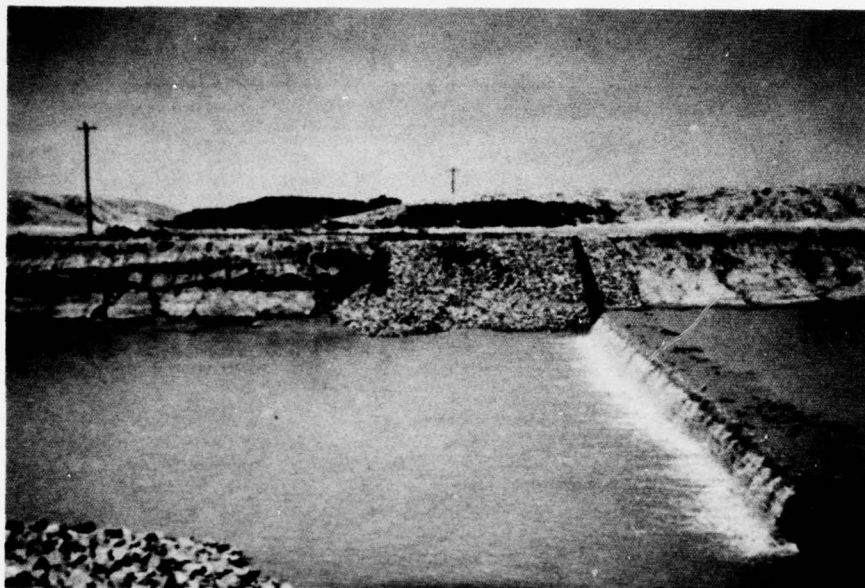
Figure 6. Reach 1 - Weir 2

12. Bank distress (riprap, fabric, and soil displacement) is evident in Figures 6, 8, and 16. Downslope bulges were visible in two cases: one, a bulge in the filter fabric near the water line on the right bank of Reach 2 - Weir 3, could be made to pump out muddy water by stepping on it, Figure 17; the second is shown in the outward displacement of riprap at the water line immediately downstream of the sheet pile on the right bank of Reach 1 - Weir 2, Figure 6. Possible explanations of the bank distress include:

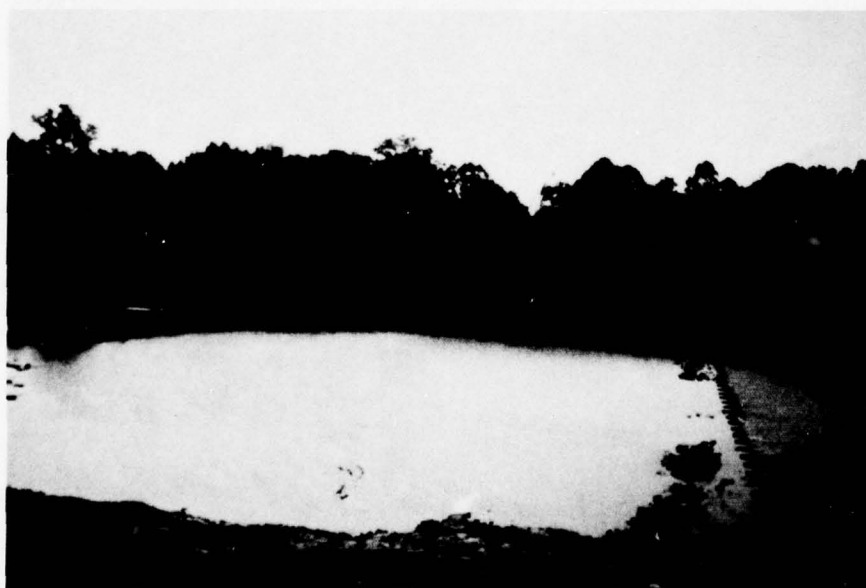
Figure 9. Reach 2 - Weir 4 upstream area

6. In order to study possible causes of the distress and then consider remedies in an organized manner, the distress problem was defined in two parts: (a) an erosion problem (i.e., gradual removal of material beneath and adjacent to the downstream edge of the slope protection) and (b) a bank distress problem (i.e., riprap and filter fabric displacement associated with apparent large soil displacements). Erosion, (a), was assumed to have been caused by downslope flow of surface water and current action. The problem was generally confined to unprotected channel banks at the downstream end of the riprap protection. It also occurred in other unprotected areas, Figure 10. Downslope erosion due to surface water flow in certain cases was combined with undercutting or large displacements of soil, Figure 6 and Figure 11 (close up), possibly caused by current erosion. Erosion also took place after large soil displacements, Figure 12, although this was not considered as part of the erosion problem in this study. The bank distress problem, (b), when present in the protected area, appeared only in the downstream riprapped area, Figures 6 and 8. Large slope displacements were evident in the unprotected channel banks near the weir, Figure 9. These were not directly considered in the bank distress problem.

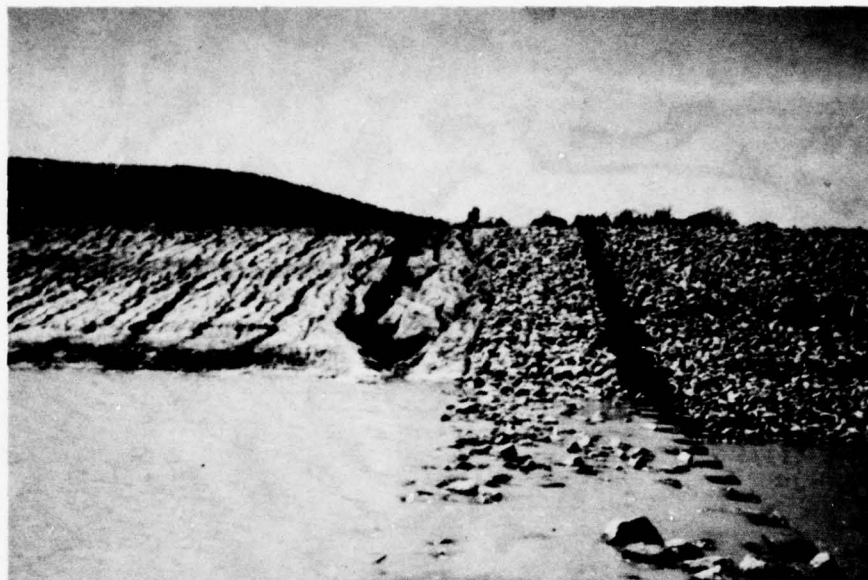
Figure 10. Erosion in unprotected bank
Reach 2 - Weir 3

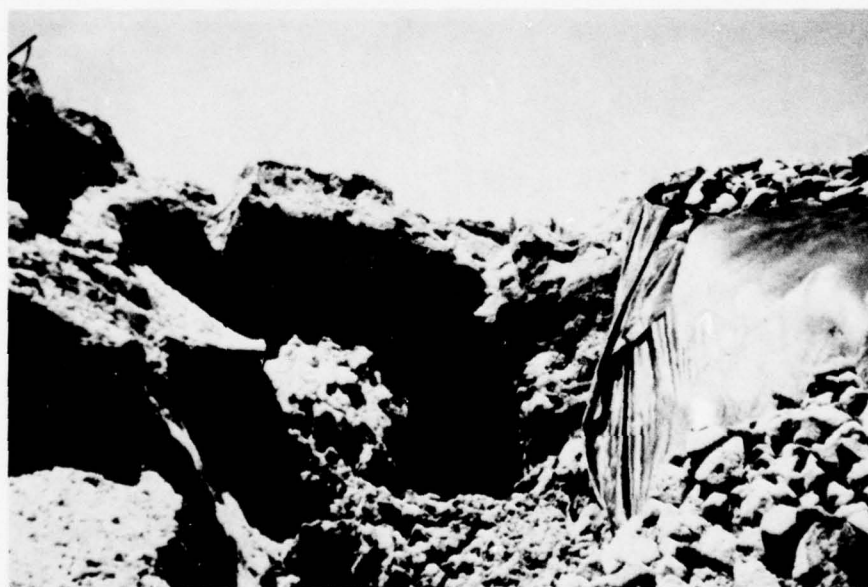
Figure 11. Edge of downstream riprap showing soil
and riprap loss Reach 1 - Weir 2

10. The erodibility of the soils was obvious from visual inspection at almost all the weirs. Soils common to this area include relatively fine silts and silty sands with little or no cohesion. The downstream edge of the slope protection is an area of concentrated erosion. The downstream end sill is carried across the bottom and up each side of the channel. The riprap and filter cloth slope protection terminate at the downstream toe of the end sill. This produces a "vee" or "trough" up the channel bank, one side having slope protection and the other side none, Figure 13. In the more erodible soils, this configuration would tend to accelerate erosion if surface runoff has access to the vee. These soils would also be more susceptible to undercutting and current erosion in the unprotected bank just downstream of the fabric and riprap. This logically would progress back to and under the fabric and riprap. This has apparently happened at several of the weirs. The erosion has removed soil from beneath the downstream

edge of the filter fabric, causing displacement of the fabric and subsequent displacement and loss of riprap, Figure 11.

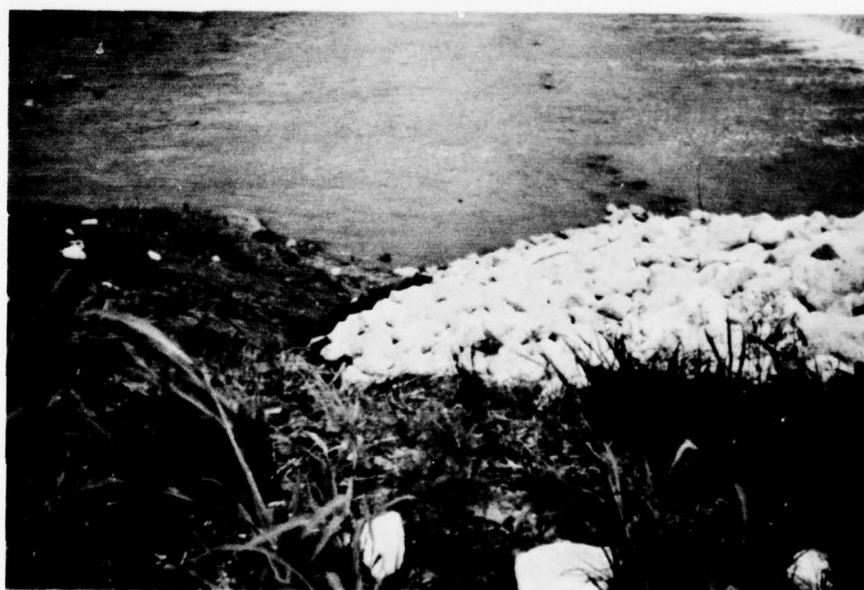
Figure 13. View of "vee" at downstream edge of riprap. End sill is visible just at water surface across channel

- 19. To alleviate the erosion problem, it is recommended that:
 - a. The "vee" shaped area extending up the bank at the downstream edge of the riprap should have protection (filter fabric and riprap) on both sides. This could be accomplished by extending slope protection another 5 to 10 ft downstream.
 - b. Surface water should be routed away from the channel banks in the area of the weir and its slope protection including a short distance upstream and downstream of slope protection. This could be accomplished by a slight slope away from the channel and/or a small protective berm just back of the top of bank.
 - c. Conventional erosion protection measures (soil stabilization with vegetation, lime, soil cement, etc.) could be used just upstream and downstream of the weir on the unprotected slopes.

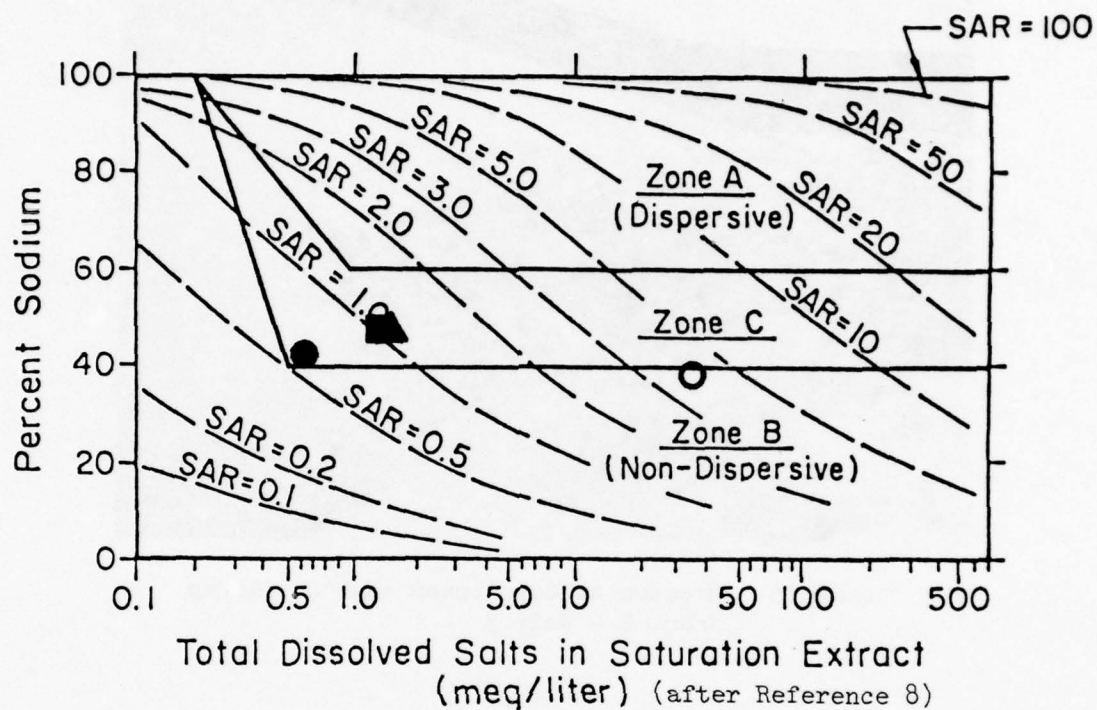
Figure 14. Relationship between dispersion and soil pore water chemistry based on pinhole erosion tests and experience with erosion in nature (Reference 8)

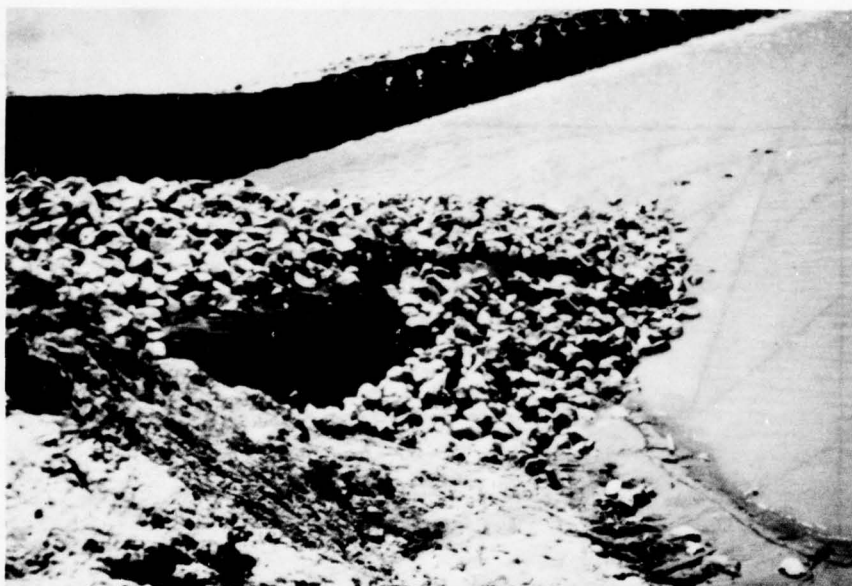
Figure 15. Erosion at downstream edge of riprap
Reach 2 - Weir 3

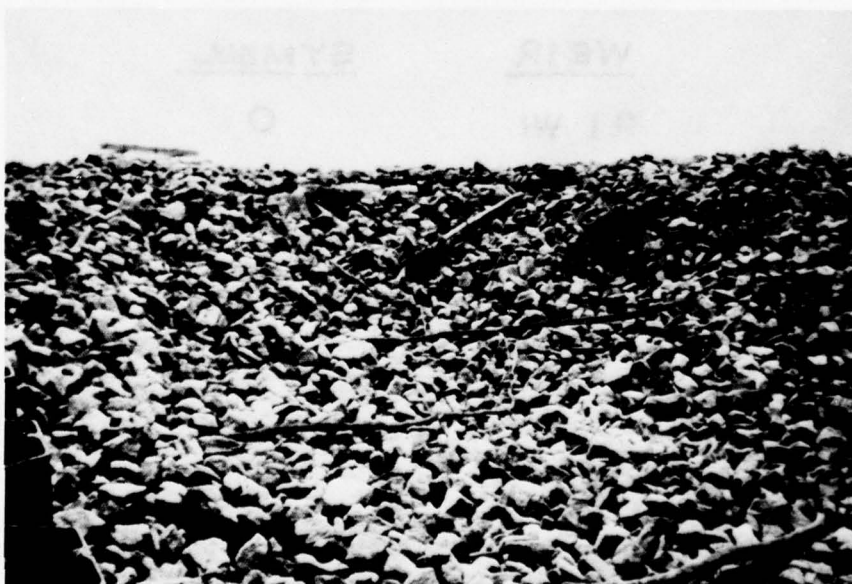
Figure 16. Bank distress at Reach 1 - Weir 2

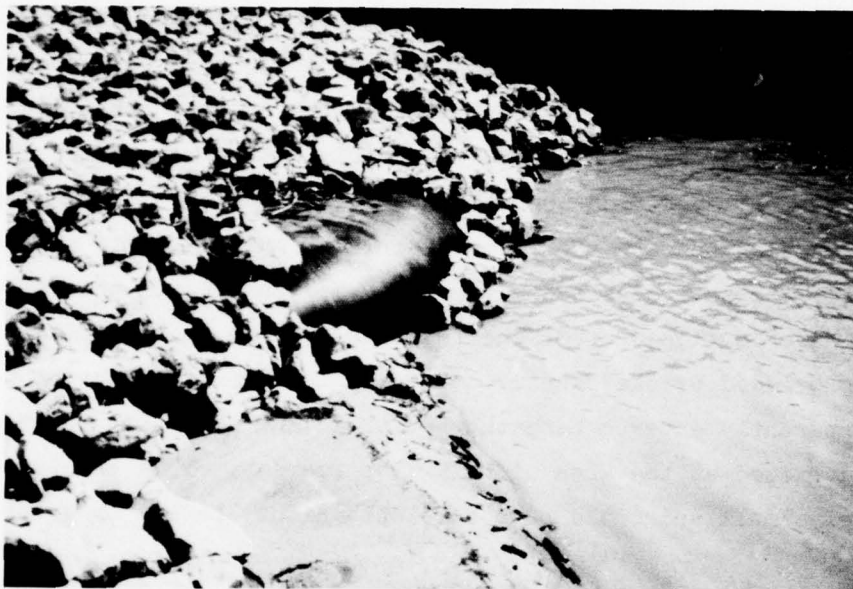
Figure 17. Bulging of filter fabric Reach 2 - Weir 3

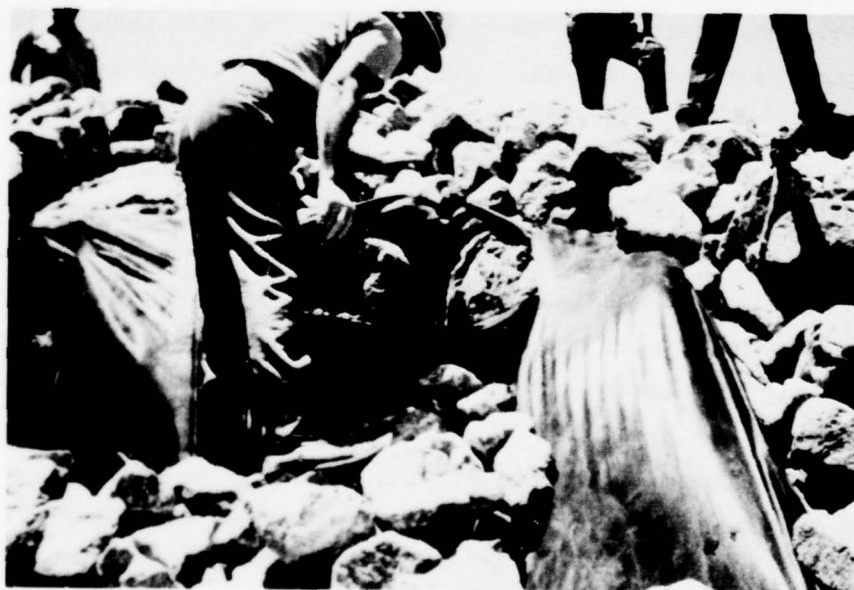
Figure 18. Erosion beneath cloth possibly prior to soil displacement Reach 1 - Weir 2
